**AIRCRAFT
ACCIDENT
REPORT**
Trans World Airlines Flight 800
Part I
Consideration of Reasonable Probable Causes

**Report on the accident to
Trans World Airlines Flight 800
Boeing 747-131, N93119
Near East Moriches, New York
July 17, 1996
by John Barry Smith,
Independent Aircraft Accident Investigator**

Part I: Consideration of Reasonable Probable Causes

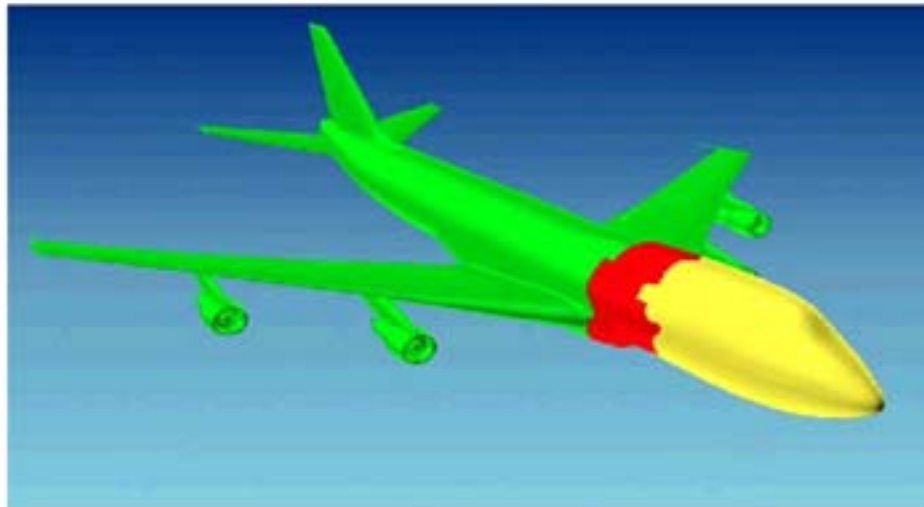
Below illustration shows the red zone of Trans World Airlines Flight 800 which is were all the first debris left the aircraft. The red zone includes the forward cargo door area but the zone is forward of the center fuel tank.
